## Flexural Performance of Corroded Reinforced Concrete Beams Repaired with CFRP Sheets

Arnon Wongkaew\*

Faculty of Engineering, Burapha University  
169 Longhard Bangsaen, T. Saensuk, A. Maung, Chon-Buri 20131

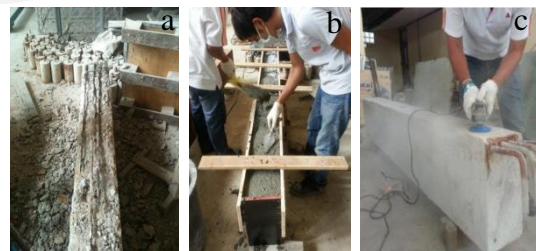
The externally bonded carbon fiber reinforced polymer (CFRP) composite sheet was utilized as a rehabilitation technique for this study. The repair processes were classified depending on the levels of corrosion as a low level of 15% and 30%, and a high level of 50%. For the low corrosion level, there was nothing additionally applied to the beams, except cleaning the remaining undamaged concrete surface by using a grinder and air blower. Then, the CFRP sheets were directly attached to those bottom beam surfaces. On the other hand, for the high corrosion level beam, the deteriorated concrete was removed and replaced using the high strength cement, SikaMicro SCC. As well as, the corroded reinforcing steels were replaced with new steel bars of the same diameter. **Fig. 3** illustrates CFRP sheets were applied to the bottom surfaces of beams as shown in **Fig. 4**. Electrical strain gauges were also attached to the top and bottom surface of concrete, as well as the outer surface of CFRP sheets at the middle span length of beam as shown in **Fig. 4**. It should be noted that all repair processes were done by specialists from SIKA product.

**Fig. 3** Repair of specimens group 2

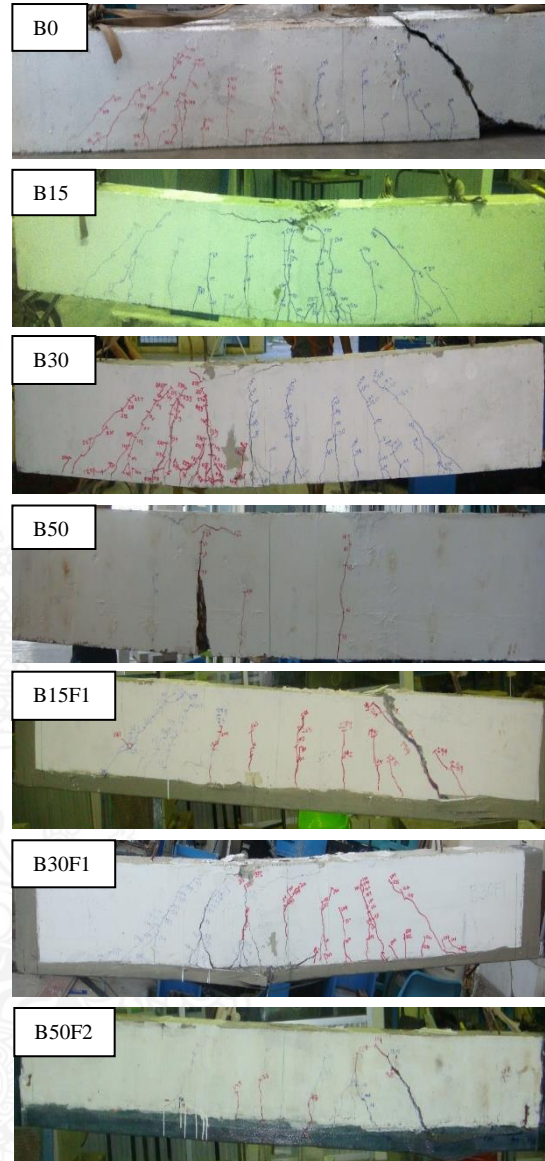
**Fig. 8** is the photos of tested specimens, B0, B15, B30, B50, B15F1, B30F1, B50F2, relatively. For group1, when the load was gradually applied to the beams, multiple flexural cracks appeared perpendicular to the bottom surface in the middle third span of the tension zone, and started to propagate and widen. Flexural yielding followed by concrete crushing occurred for all specimens in this group, except B0 and B50. The flexural-shear crack of B0 was so severe leading to failure before crushing of compression surface of the beam. On the other hand, B50 failed by significantly widen of the vertical crack perpendicular to the bottom surface and following with a rupture of the

**Fig. 8** Crack patterns and failure modes of test specimens

corroded tensile bars. Specimens B15F1, B30F1, and B50F2 have the crack patterns similar to those of the previous group. The failure mode B15F1 and B50F2 can be described as Type 4 which failed by a combination of flexural failure of the bottom tensile reinforcement and shear failure with fracture of CFRP sheets at the support. However, B30F1 can be

pronounced as Type 1 which failed by flexural failure of the bottom tensile reinforcement and fracture of CFRP sheets at the middle of the beam span. It should be noted that there is no failure in epoxy material obviously noticed from the test. This maybe results from the additional CFRP sheets wrapped around the beam cross section at the supports.
