## The Study on High Temperature Degradation of AISI 1020 Low Carbon Steel in the Carburization State

### Abstract

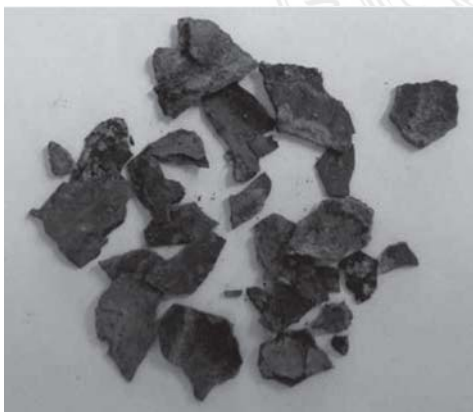
**Figure 3** Oxide scales spalling from the surface of the aged specimen

Normally, the oxide product layers in of steel under the simulated oxidizing / carburizing environment are discontinuous and loosely adhered to the surface (Jones, 1992). Thus, it is non-protective. The different thermal expansion of steel can potentially enhance the spalling of the corrosion scales (McCafferty, 2010), as displayed in Figure 3. The prolonged exposure time and the increase in the number of the exposure cause the rapid formation of the oxide scales.

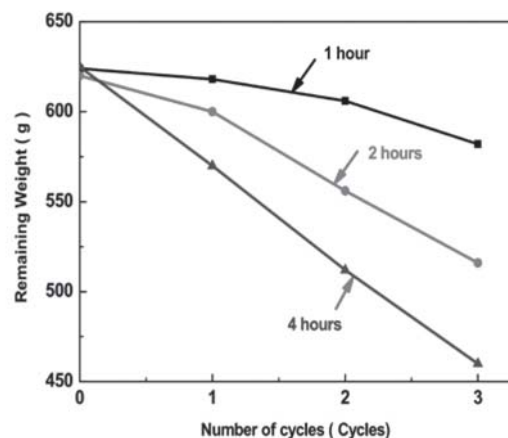
The variation in the weight of the steel samples after the simulated oxidizing / carburizing environment with the different holding times and number of exposure is shown in Figure 4.

**Figure 4** The variation in the weight of the steel specimens exposed to the simulated oxidizing / carburizing environment with the different holding times and number of exposure

**Figure 5** The microstructure of fresh specimen from Figure 4, the weight of specimens basically decreases after exposure and when the exposure time is longer and the number of the exposure is increased, the weight of specimen significantly decreases
